March 9, 2018

FILE: 16-092-01

**Re: Bear Mountain 2016-2017 Annual Groundwater Monitoring Report**

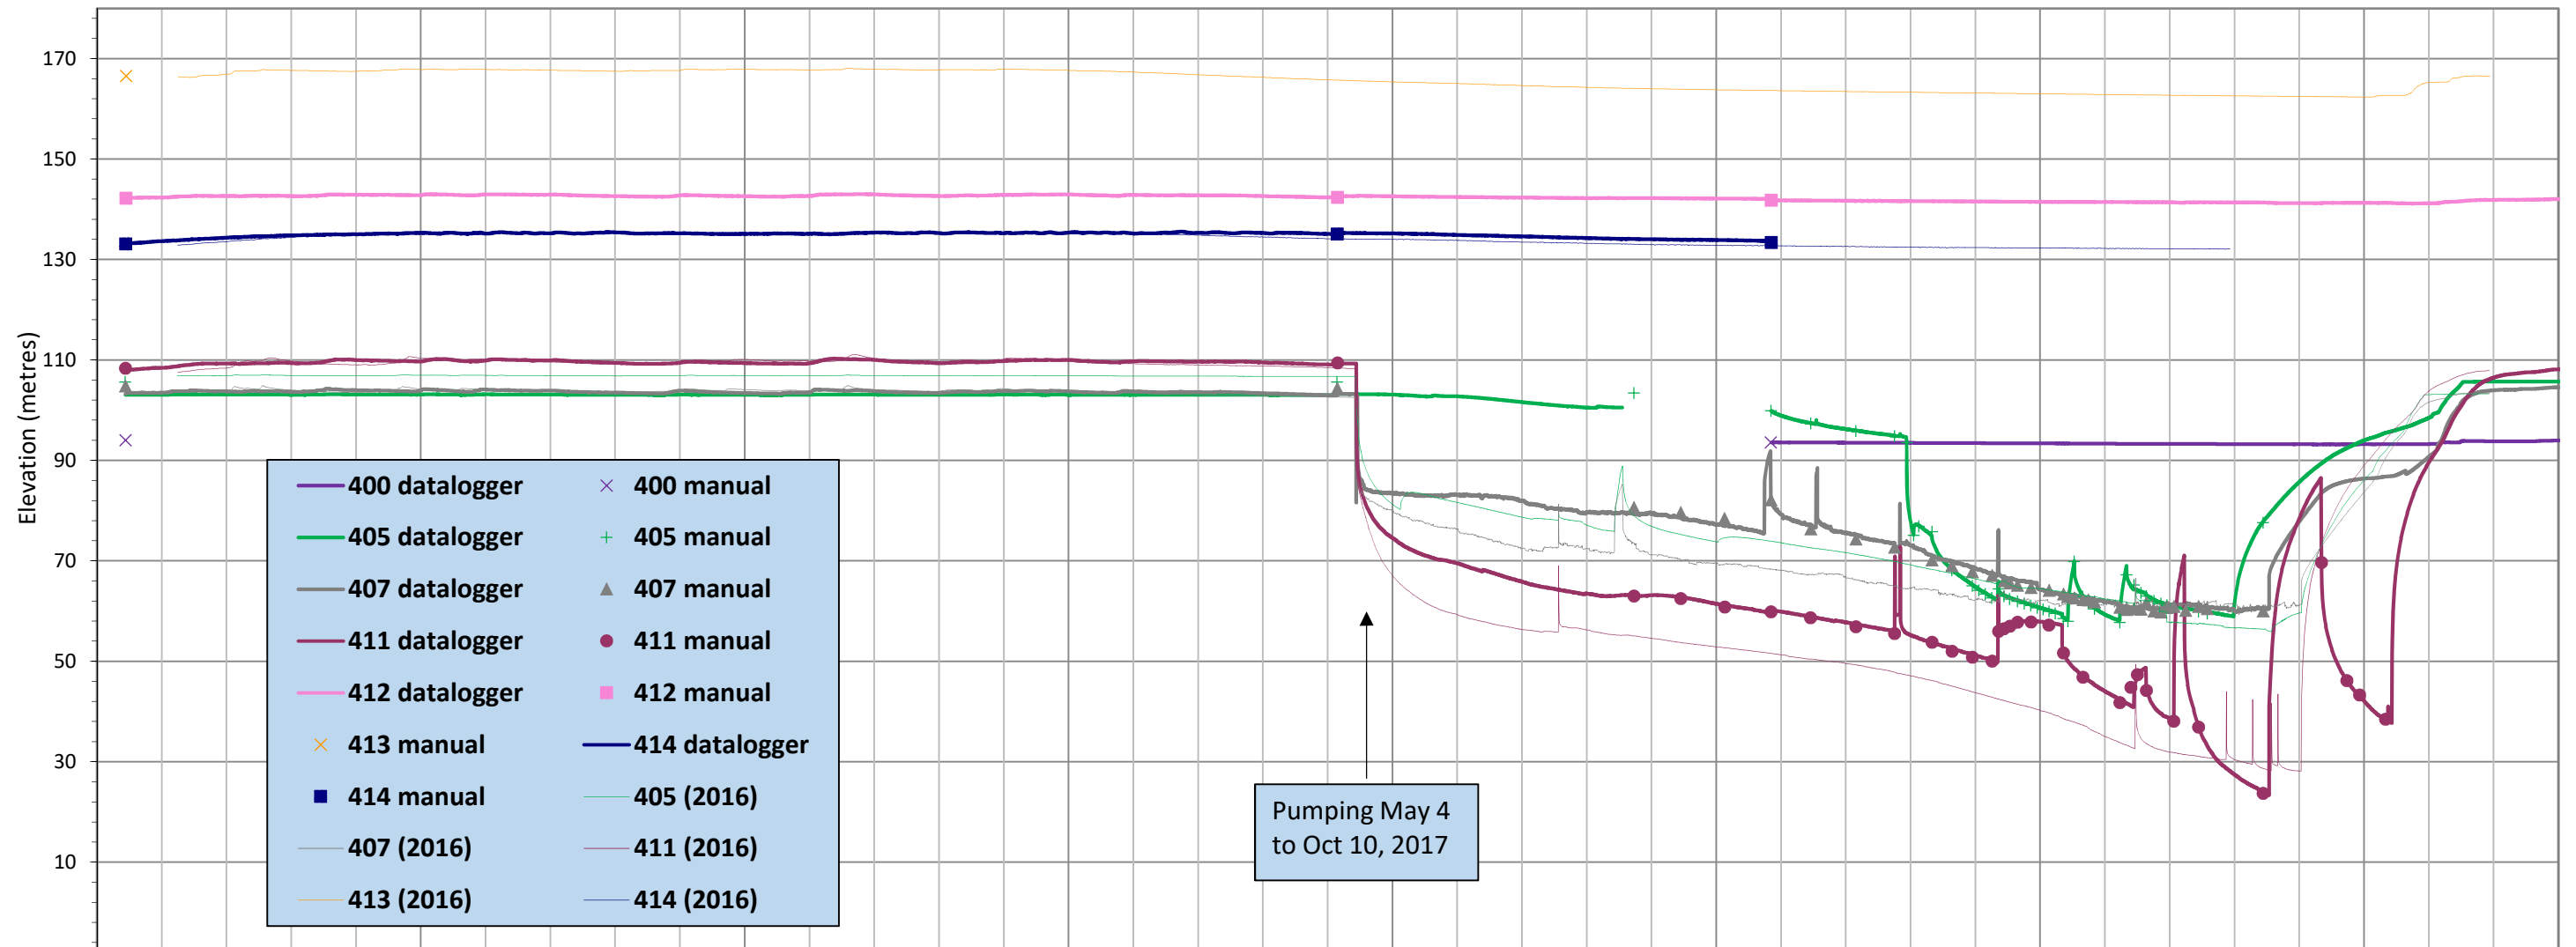
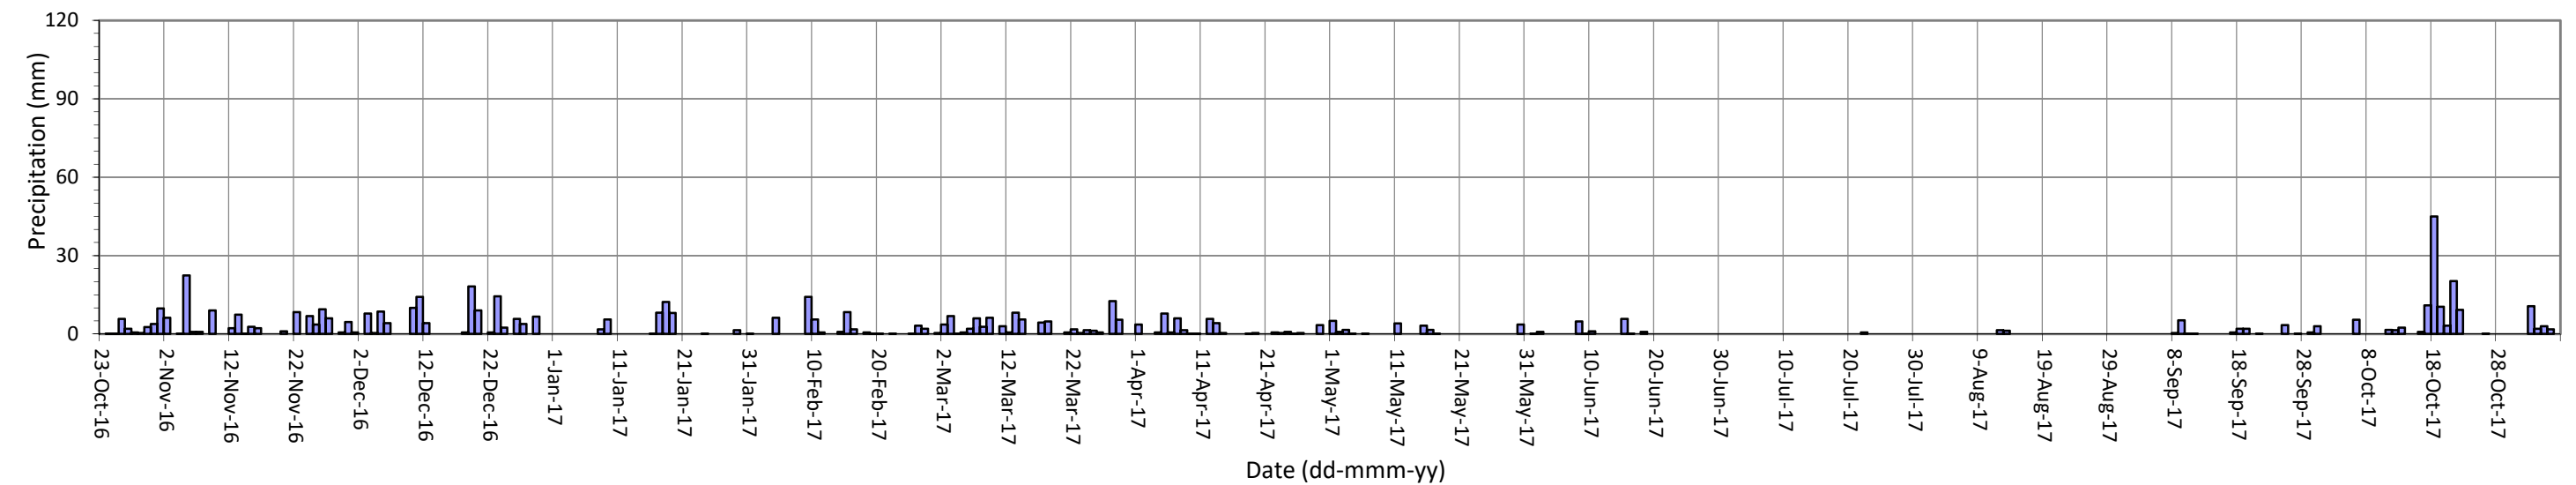
**Figure 2: Bear Mountain Golf Course 2016-2017 Groundwater Levels**

Figure 2 illustrates groundwater elevations for the selected wells during the 2016-2017 monitoring period. For comparison, water level data from the 2015-2016 monitoring period are also plotted on the same figure using a lighter line weight and a one year shift in the date.

From the data, 2016-2017 groundwater elevations in the bedrock aquifer remained similar to prior years. As in previous years (Thurber, 2012, 2013, 2014, 2015, 2016; WWAL, 2017b), aquifer levels fluctuated seasonally on the order of 2 to 5 m, peaked in the early spring (February to April) and were lowest in the early fall. The groundwater flow direction in the north part of the golf course was inferred to be towards the southeast based on the relative static water levels in the wells 400, 407, 411, 412 and 414.

Water levels in the pumping wells showed a similar fluctuation to the observation wells in the winter and early spring when they were not being pumped. During the 2017 irrigation season, water levels in the irrigation wells were drawn down due to pumping by a maximum of approximately 35 m in well 405, 43 m in well 407 and 86 m in well 411 (compared to 50, 43, and 80 m, respectively during the previous year). Water level drawdown in the pumping wells showed a relatively rapid decline when extraction was initiated and then a gradual flattening after prolonged pumping. When pumping was stopped, the water levels in the wells recovered relatively quickly following the first significant precipitation events. In 2017, this occurred around the middle of October.

Following shutdown of the pump in well 411 for the winter on October 10, water levels in the pumping wells recovered to 100% of the pre-pumping groundwater levels after approximately 5 weeks. This can be compared to a full recovery after ~4 weeks in 2016 (WWAL, 2017b), ~5 weeks in 2015 (Thurber, 2016), ~6 weeks in 2014

As observed in previous years, extraction pumping of irrigation wells did not appear to impact the water levels in the observation wells (413 and 414 in the past, and 400 and 412 currently). This is consistent with the conceptual understanding of the aquifer described in previous reports that the observation wells are considered hydraulically separate from the permeable fault/fracture zone that provides the source of water for the irrigation wells.

It is recommended that the annual groundwater monitoring and reporting program be maintained in 2017-2018. The dataloggers should be downloaded at the start and the end of the irrigation season, or approximately in May and November.
